**SUMMARY REPORT
668 DAHLIA DRIVE (FORMERLY 647 DAHLIA DRIVE)
LAUREL BAY MILITARY HOUSING AREA
MARINE CORPS AIR STATION BEAUFORT
BEAUFORT, SC**

Contract Number: N62470-14-D-9016
CTO WE52
JUNE 2021

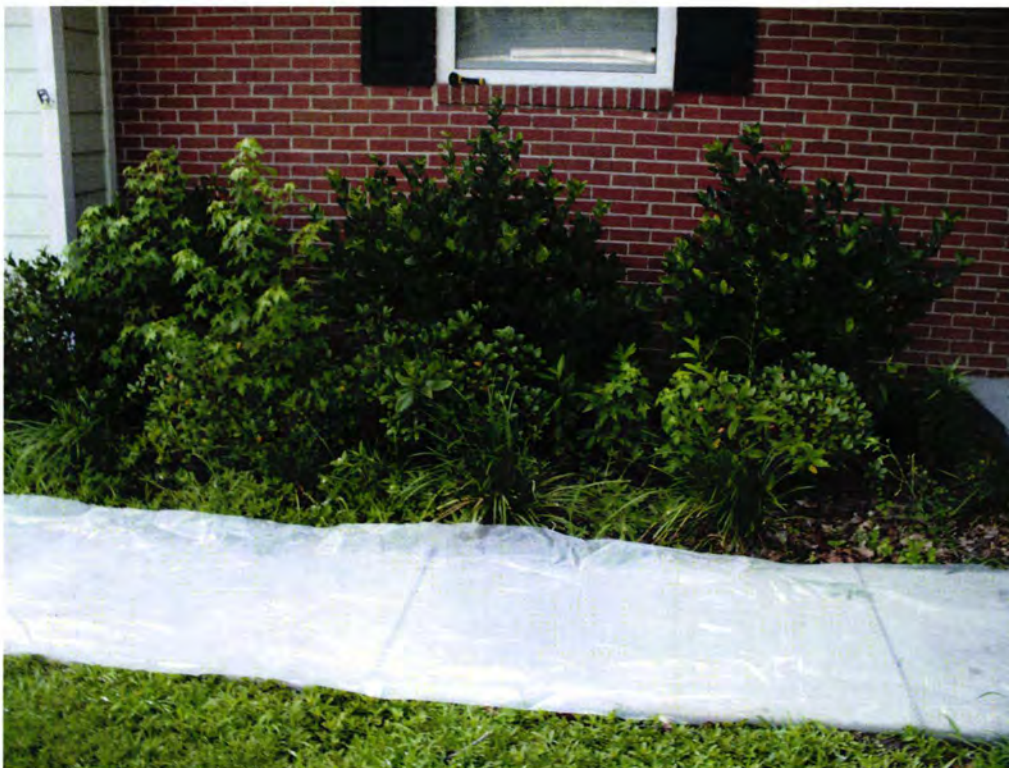
On June 17, 2010, a single 280 gallon heating oil UST was removed from the front landscaped bed adjacent to the driveway at 668 Dahlia Drive (Formerly 647 Dahlia Drive). The former UST location is indicated on Figures 2 and 3 of the UST Assessment Report (Appendix B). The UST was removed and properly disposed of (i.e., shipped offsite for recycling or transported to a landfill). There was no visual evidence (i.e., staining or sheen) of petroleum impact at the time of the UST removal. According to the UST Assessment Report (Appendix B), the depth to the base of the UST was 5'4" bgs and a single soil sample was collected from that depth. The sample was collected from the fill port side of the former UST to represent a worst case scenario.

Picture 1: Location of UST 647Dahlia.

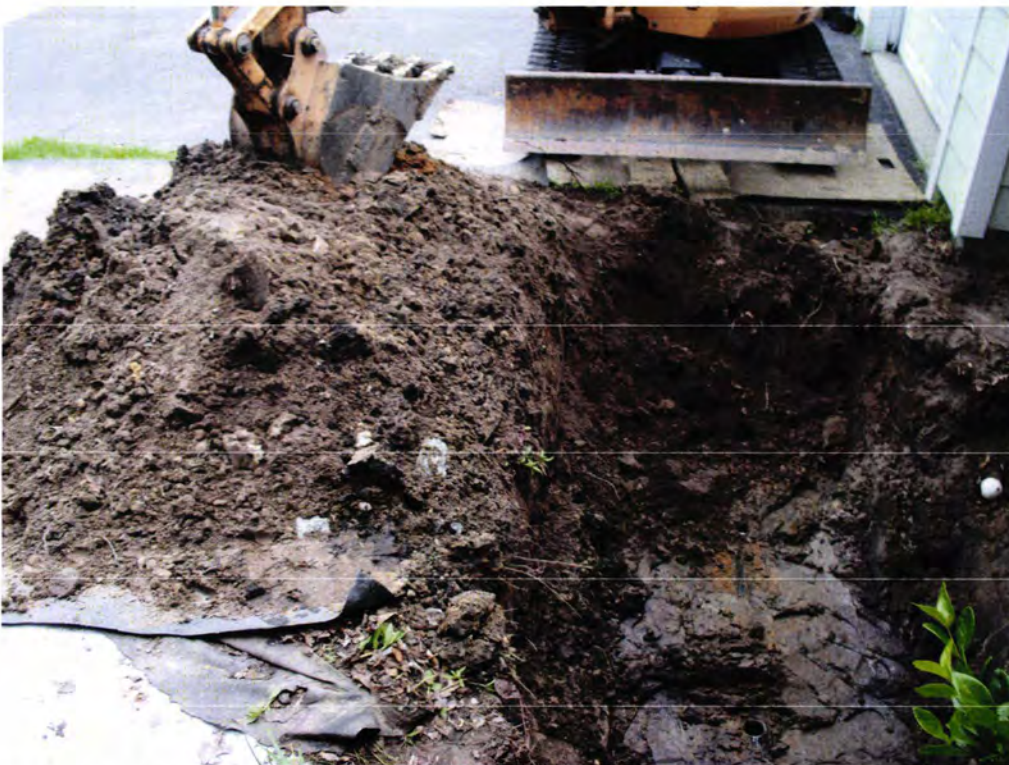
Corrosion, pitting and holes were found throughout the tank.

Corrosion and pitting were found on the surface of the steel vent pipe. Copper supply and return lines were sound.

Picture 2: UST 647Dahlia during excavation.
