SUMMARY REPORT  
253 AZALEA DRIVE (FORMERLY 814 AZALEA DRIVE)  
LAUREL BAY MILITARY HOUSING AREA  
MARINE CORPS AIR STATION BEAUFORT  
BEAUFORT, SC

JUNE 2021

South Carolina Department of Health and Environmental Control (SCDHEC)  
**Underground Storage Tank (UST) Assessment Report**

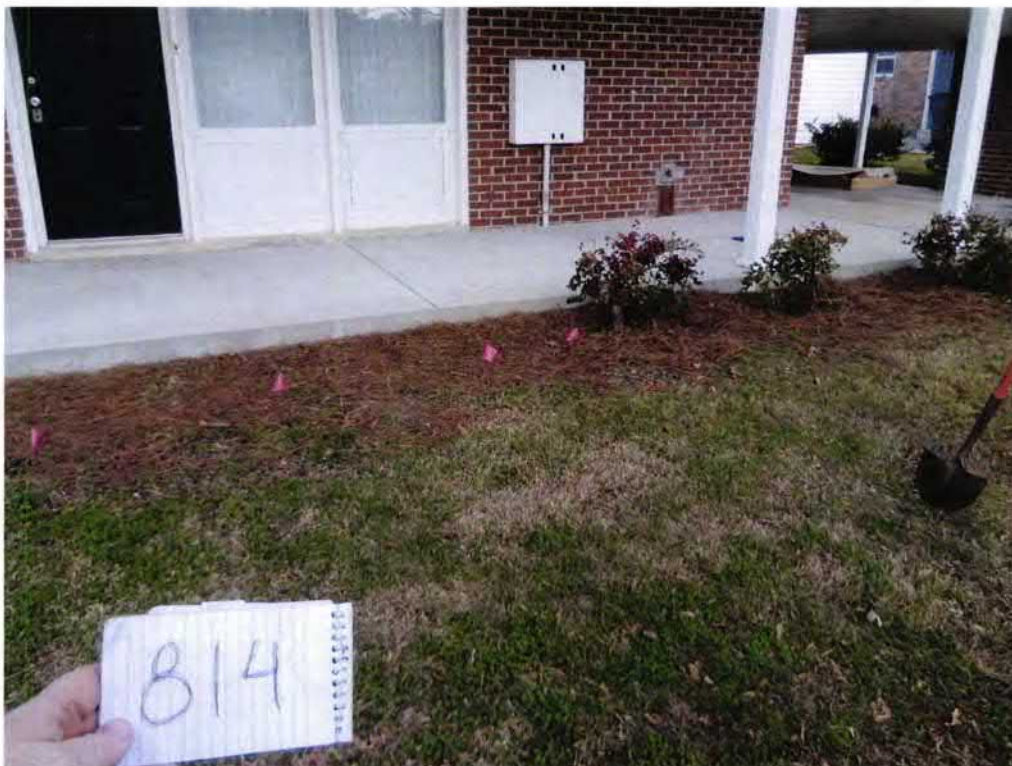
Picture 1: Location of UST 814Azalea.

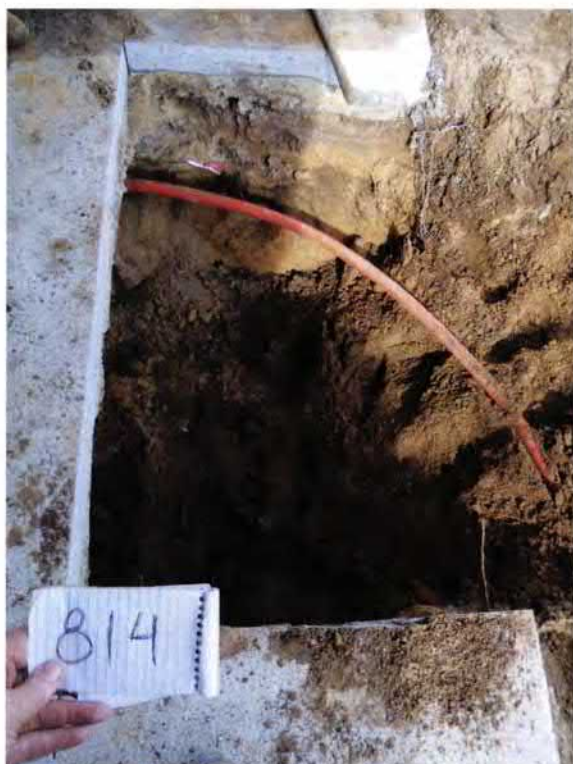
Picture 2: UST 814Azalea excavation.
