SUMMARY REPORT
283 AZALEA DRIVE (FORMERLY 818 AZALEA DRIVE)
LAUREL BAY MILITARY HOUSING AREA
MARINE CORPS AIR STATION BEAUFORT
BEAUFORT, SC

JUNE 2021

South Carolina Department of Health and Environmental Control (SCDHEC) Underground Storage Tank (UST) Assessment Report

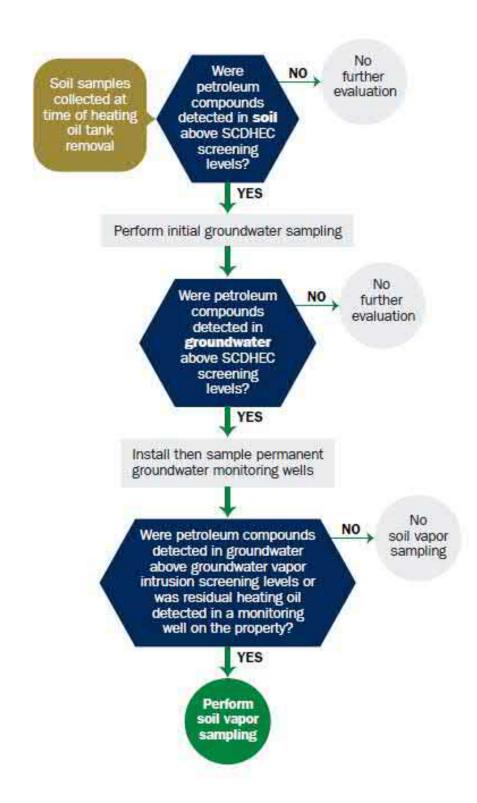
Appendix A - Multi-Media Selection Process for LBMH

The results of the soil sampling at each former UST location were used to determine if a potential for groundwater contamination exists (i.e., soil results greater than RBSLs) and subsequently to select properties for follow-up initial groundwater assessment (IGWA) sampling. The results of the IGWA sampling (if necessary) are used to determine the presence or absence of the aforementioned COPCs in groundwater and identify whether former UST locations will require additional delineation of COPCs in groundwater. In order to delineate the extent of impact to groundwater, permanent wells are installed and a sampling program is established for those former UST locations where IGWA sampling has indicated the presence of COPCs in excess of the SCDHEC RBSLs for groundwater. Groundwater analytical results are also compared to the site specific groundwater vapor intrusion screening levels (VISLs) to evaluate the potential for vapor intrusion and the necessity for an investigation associated with this media. A multi-media investigation selection process tree, applicable to the LBMH UST investigations, is presented as Appendix A.
