SUMMARY REPORT  
316 AZALEA DRIVE (FORMERLY 831 AZALEA DRIVE)  
LAUREL BAY MILITARY HOUSING AREA  
MARINE CORPS AIR STATION BEAUFORT  
BEAUFORT, SC

Contract Number: N62470-14-D-9016  
CTO WE52  
JUNE 2021

South Carolina Department of Health and Environmental Control (SCDHEC)  
**Underground Storage Tank (UST) Assessment Report**

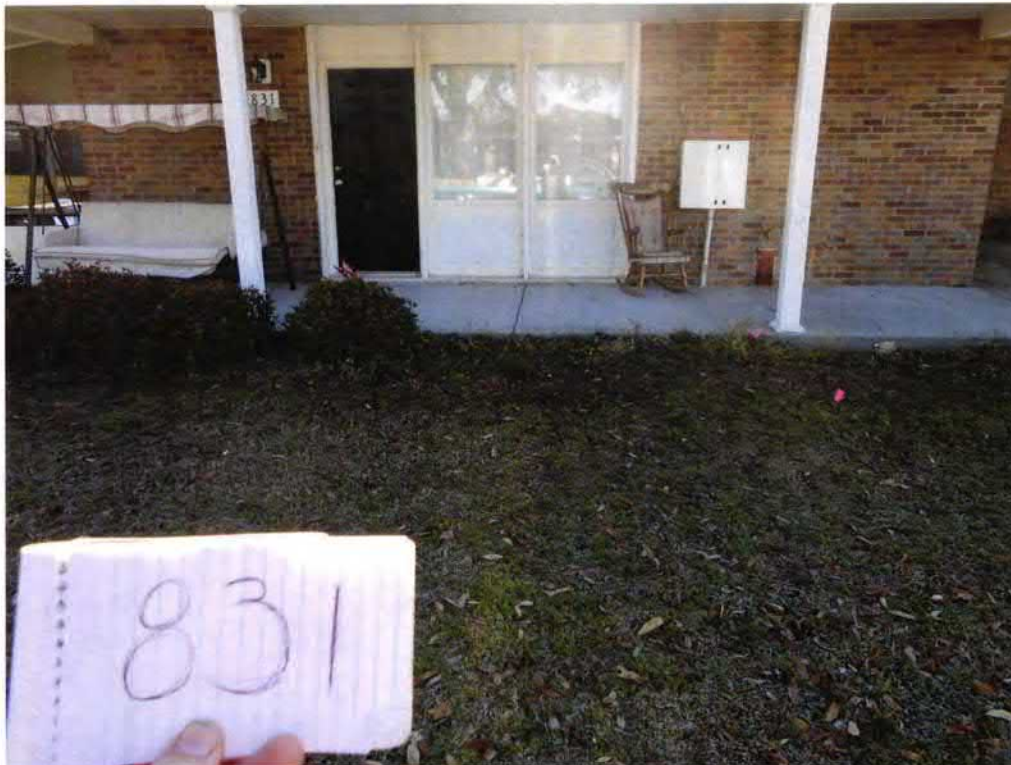
Picture 1: Location of UST 831Azalea.

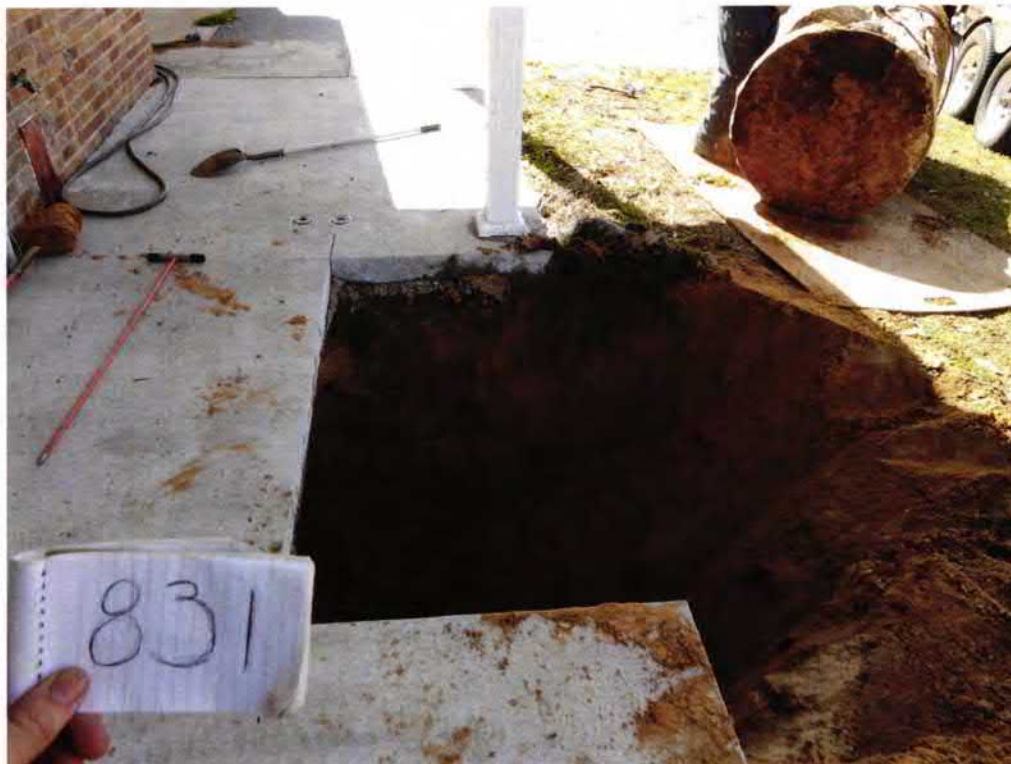
- M. Method of disposal for any USTs removed from the ground (attach disposal manifests)  
UST 831Azalea was removed from the ground and disposed at a  
"Subtitle D" landfill. See Attachment "A".
- 
- N. Method of disposal for any liquid petroleum, sludges, or wastewaters removed from the USTs (attach disposal manifests)  
UST 831Azalea was previously filled with sand by others.
- 
- O. If any corrosion, pitting, or holes were observed, describe the location and extent for each UST  
Corrosion, pitting and holes were scattered about the tank.
-

Picture 2: UST 831Azalea excavation.
