SUMMARY REPORT 23 COBIA DRIVE (FORMERLY 868 COBIA DRIVE) LAUREL BAY MILITARY HOUSING AREA MARINE CORPS AIR STATION BEAUFORT BEAUFORT, SC

JUNE 2021

South Carolina Department of Health and Environmental Control (SCDHEC) Underground Storage Tank (UST) Assessment Report

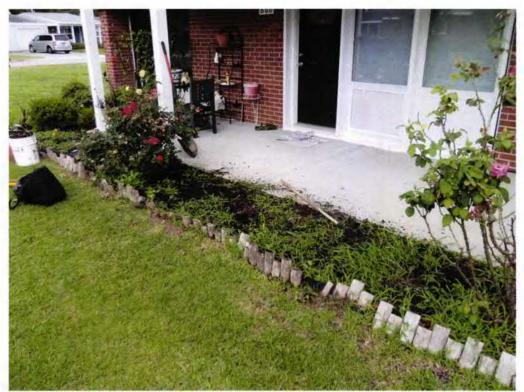
Picture 1: Location of UST 868Cobia.

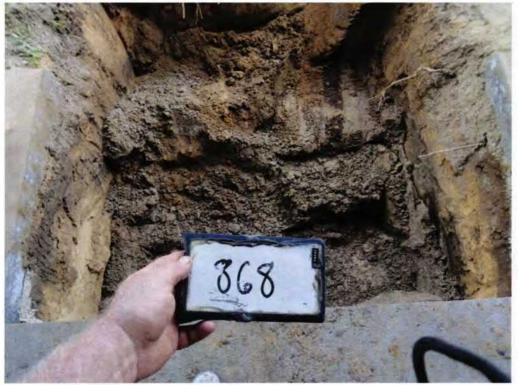
O. If any corrosion, pitting, or holes were observed, describe the location and extent for each UST Corrosion, pitting and holes were scattered about the tank.

Picture 2: UST 868Cobia excavation.
