SUMMARY REPORT  
132 BARRACUDA DRIVE (FORMERLY 909 BARRACUDA DRIVE)  
LAUREL BAY MILITARY HOUSING AREA  
MARINE CORPS AIR STATION BEAUFORT  
BEAUFORT, SC

JUNE 2021

Contract Number: N62470-14-D-9016  
CTO WE52  
JUNE 2021

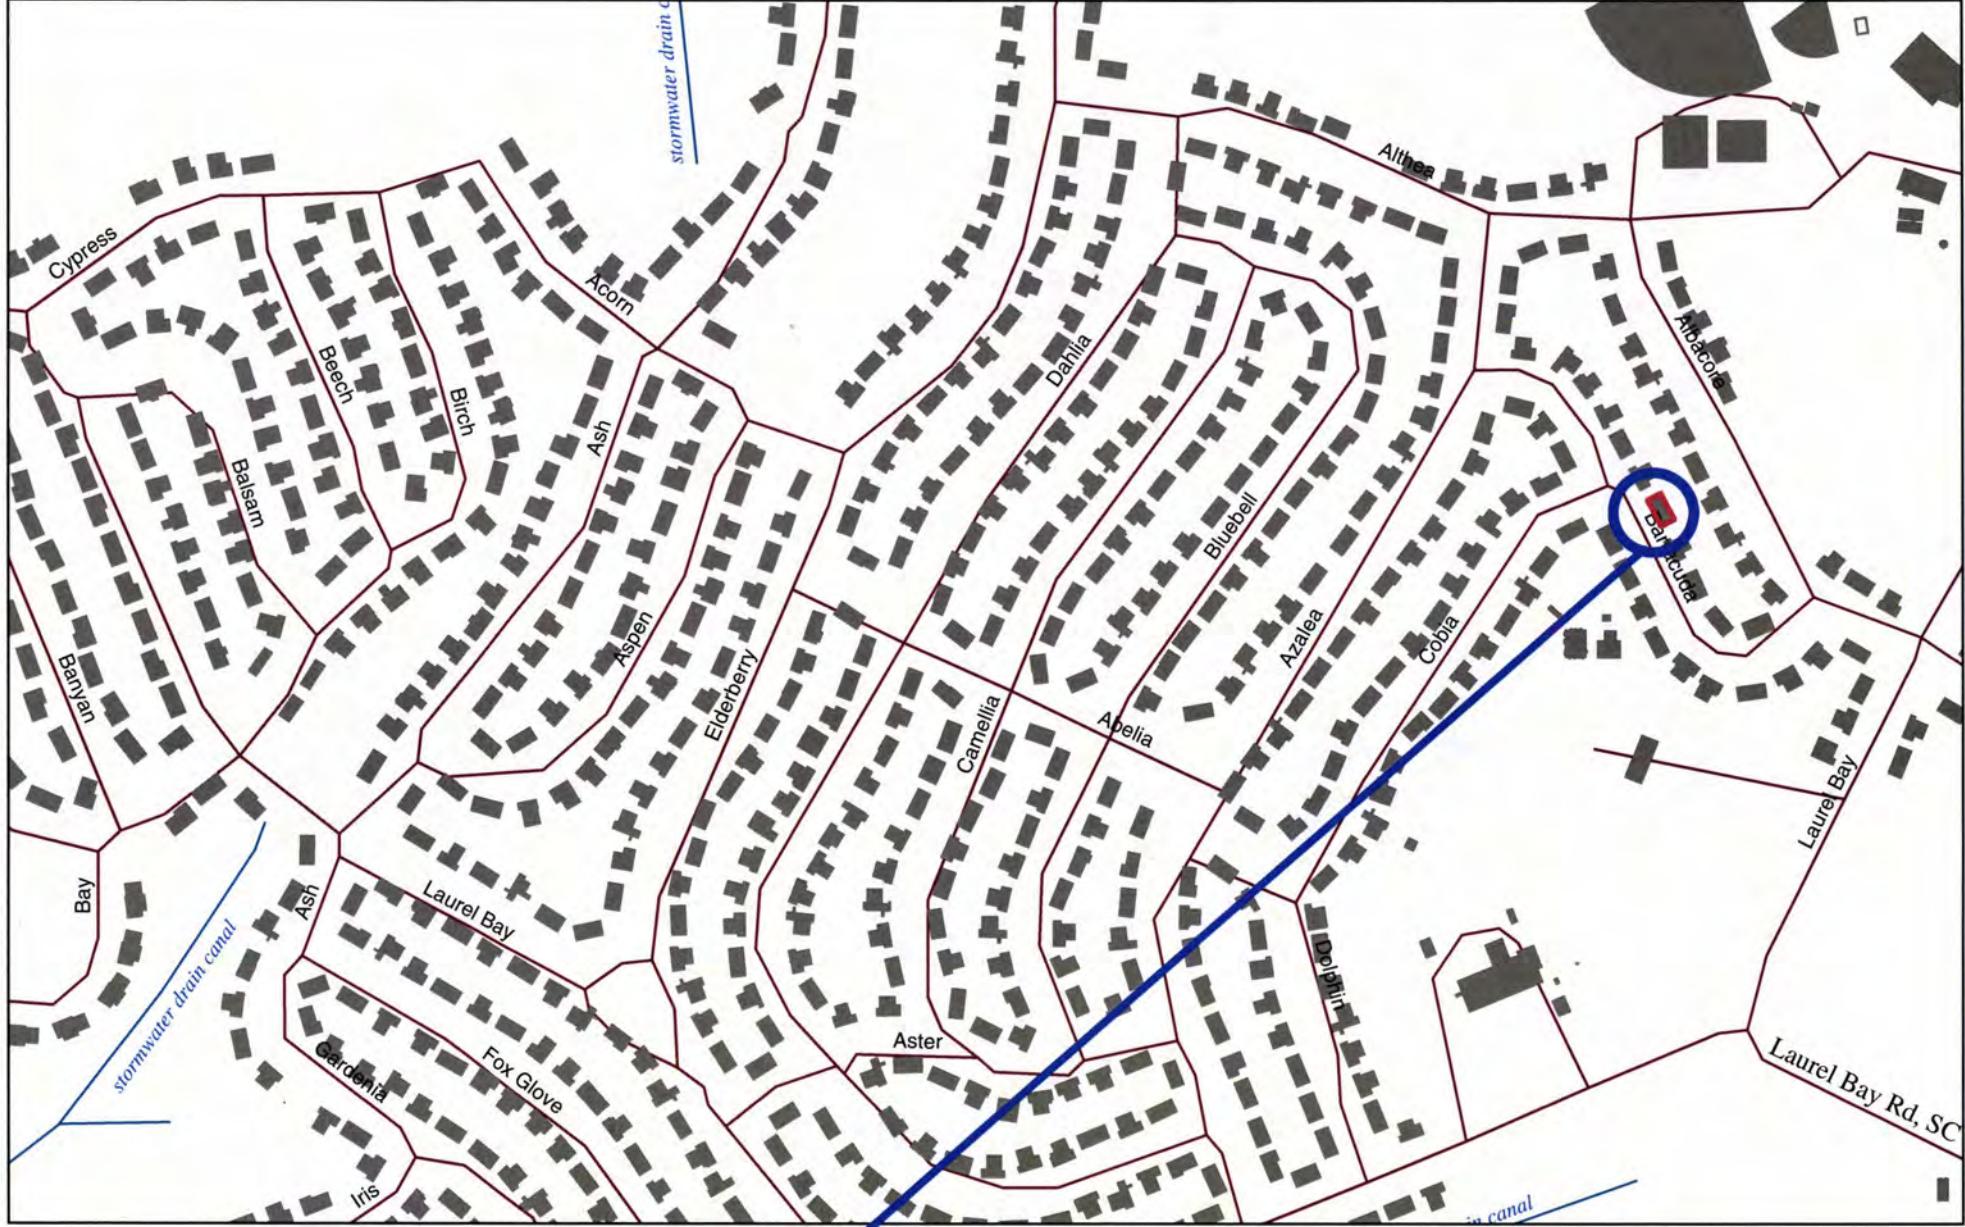
**909 BARRACUDA ST.**

**You must supply a scaled site map. It should include all buildings, road names, utilities, tank and dispenser island locations, labeled sample locations, extent of excavation, and any other pertinent information.**

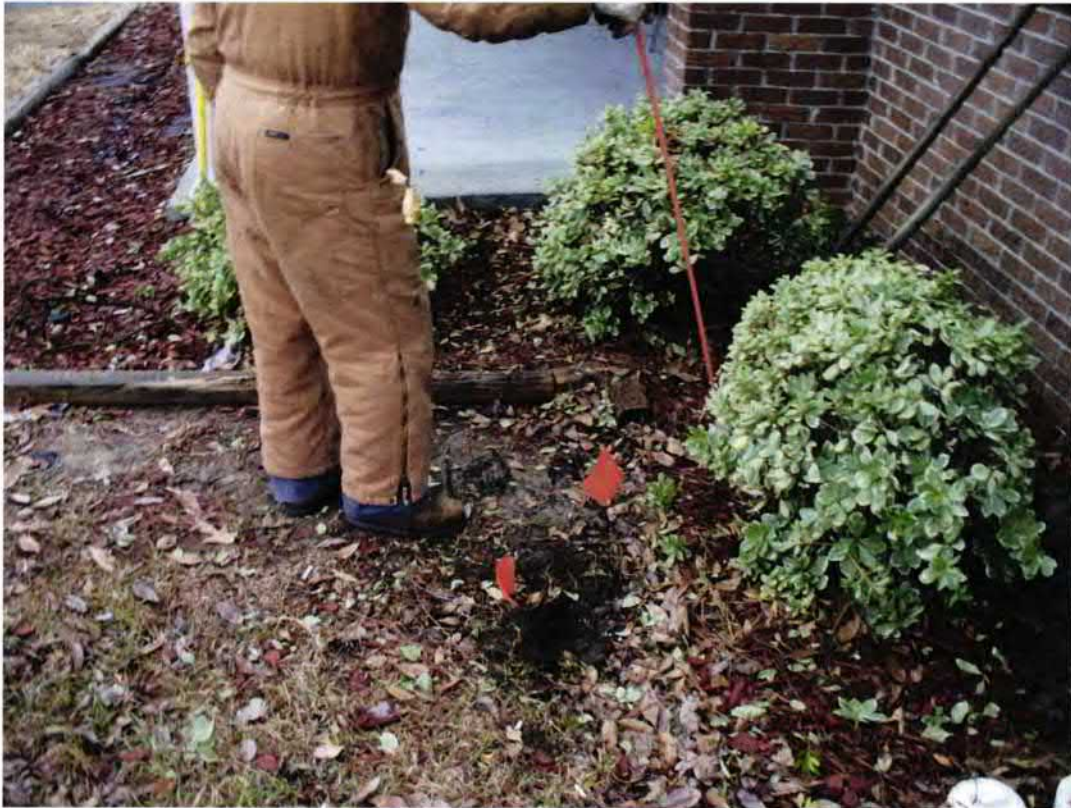
Picture 1: Location of UST 909 Barracuda.
